DC-17-02998

SUZANNE CALLAWAY-DAVIS

AMAZON.COM LLC, OLADAYA  
ANIPOLE, INPAX SHIPPING  
SOLUTIONS INC., AND INSS, LLC*Defendants*§  
§  
§  
§  
§  
§  
§  
§  
§

**PLAINTIFF SUZANNE CALLAWAY-DAVIS' ORIGINAL PETITION**

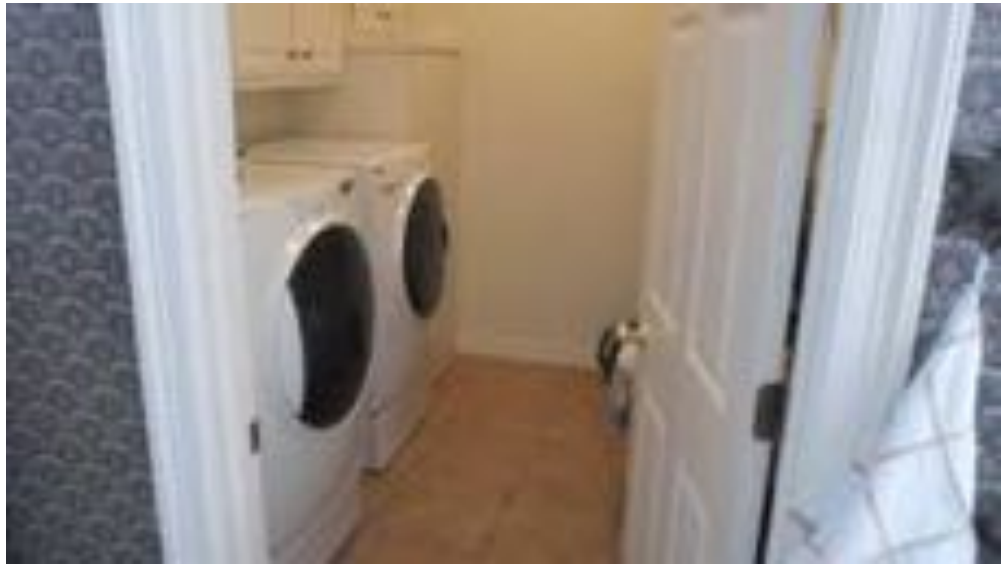
46 50-LAUNDRY CROWN

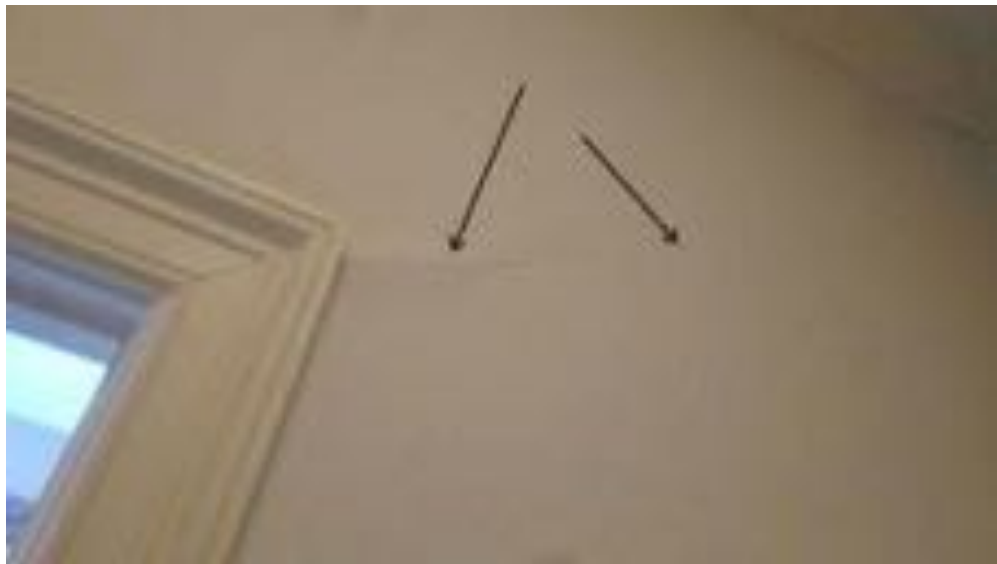
48 52-LAUNDRY WALL AND  
CROWN

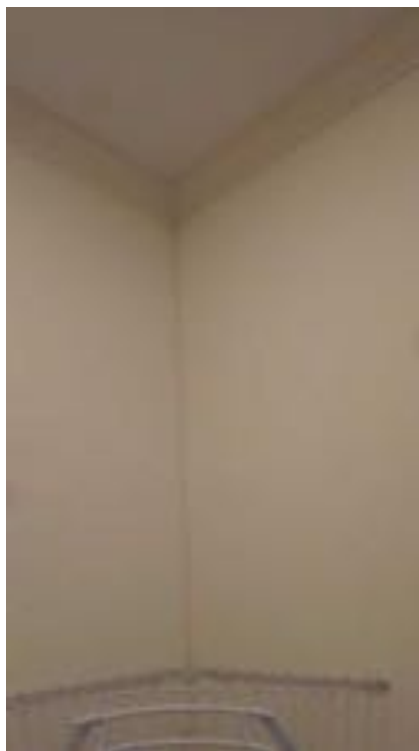
49 53-CRACKED DRYWALL IN  
LAUNDRY

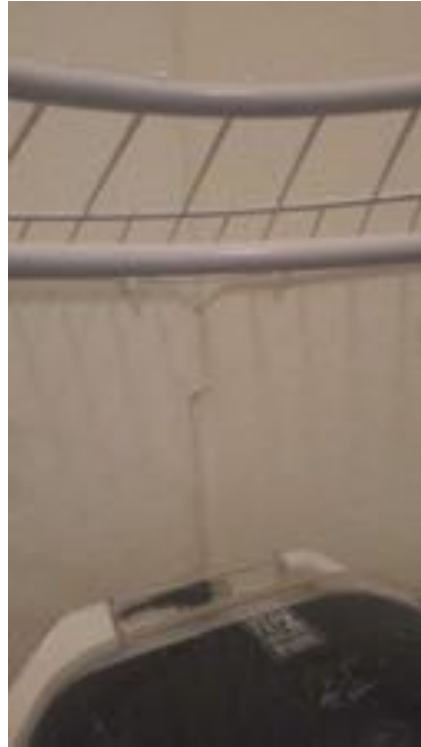
50 54-BASE SEPARATION

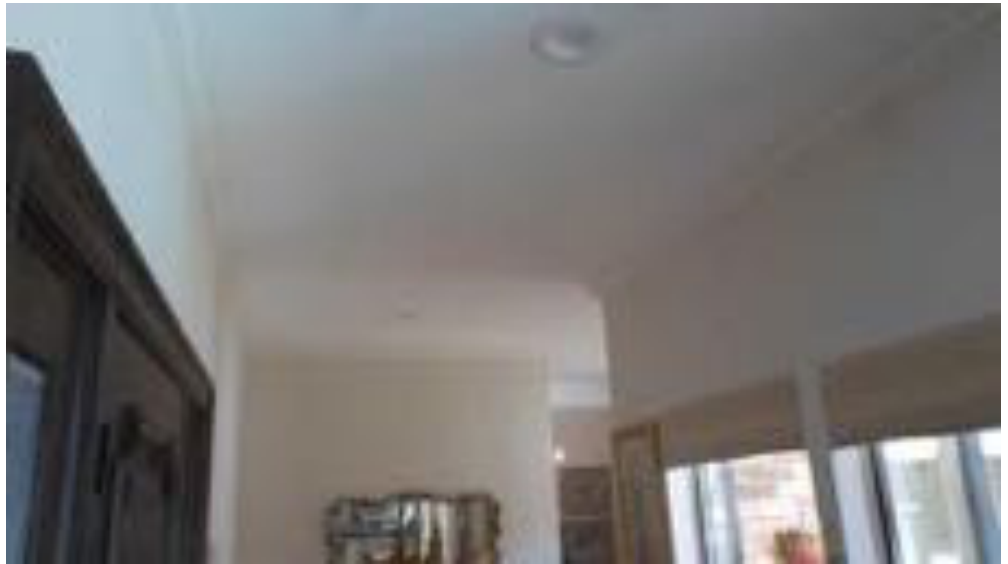
- 54 59-FOYER WALL CRACKS  
Date Taken: 8/14/2012  
Taken By: Tony Sherriff

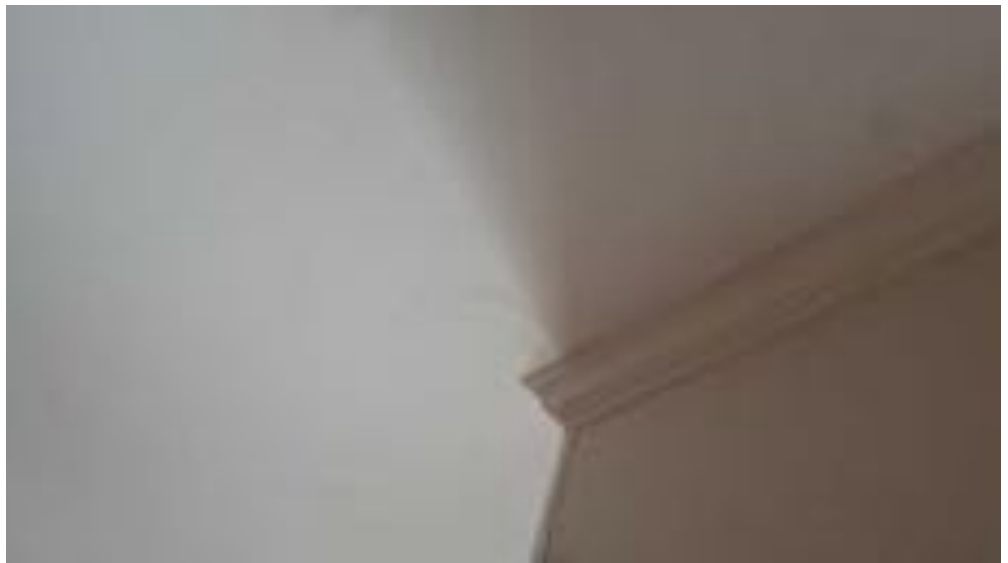
58 65-FOYER DRYWALL CEILING  
CRACK

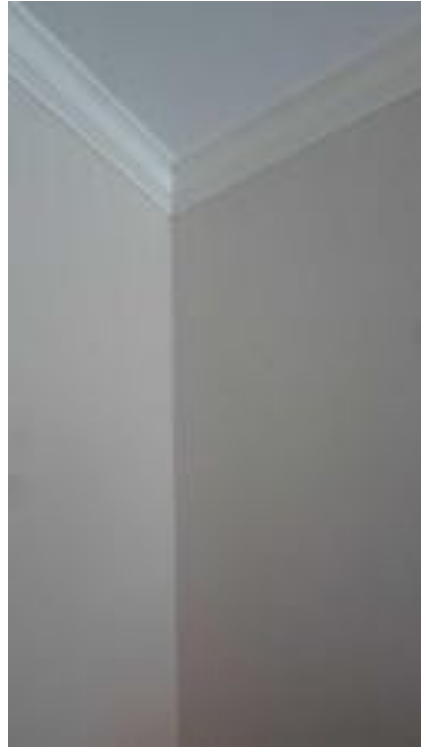
- 75 86-master bedroom crown  
Date Taken: 8/14/2012  
Taken By: Tony Sherriff

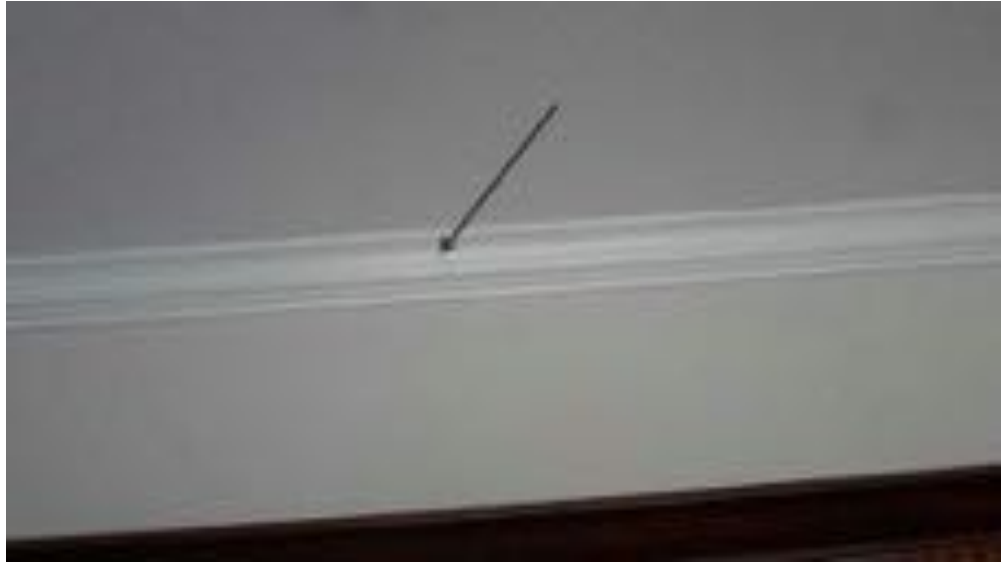
- 77 88-master bedroom crown  
separation  
Date Taken: 8/14/2012  
Taken By: Tony Sherriff

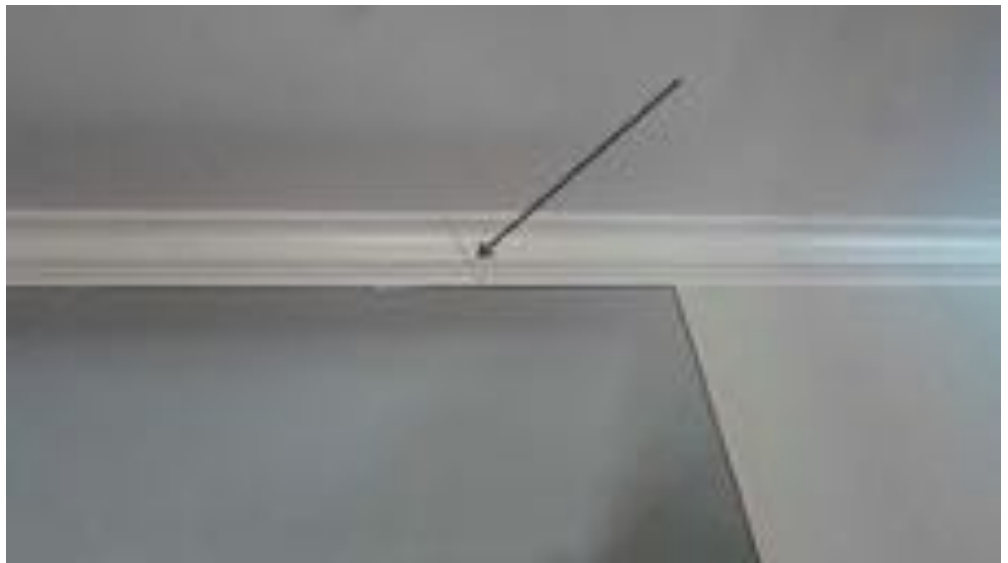
- 78 89-laster bedroom crown  
separation  
Date Taken: 8/14/2012  
Taken By: Tony Sherriff

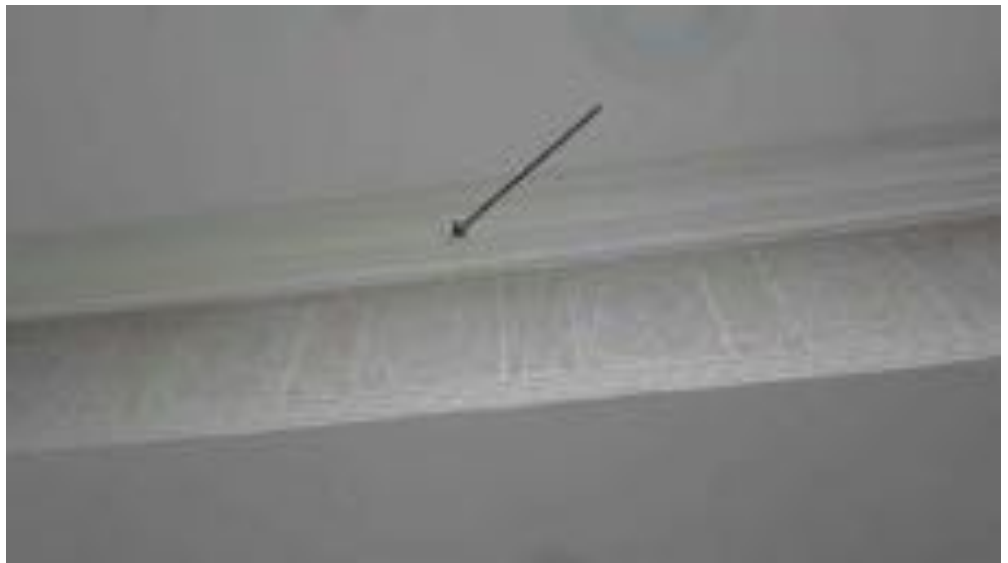
- 86 98-crown separation  
Date Taken: 8/14/2012  
Taken By: Tony Sherriff

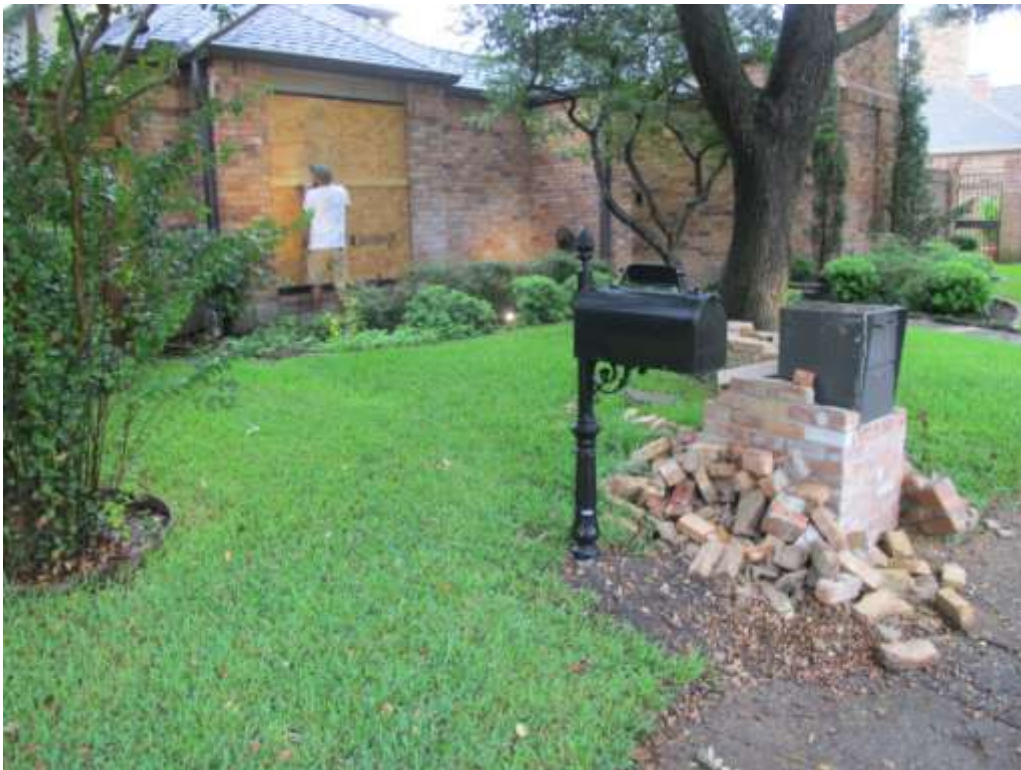
Photo 4: Damage remaining during BE visit.

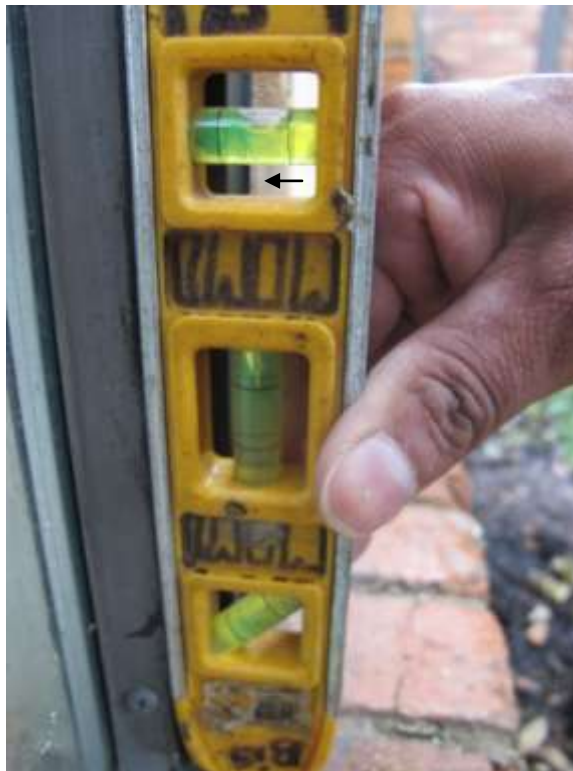
Photo 13: Inward window frame bow or displacement out of vertical at impact area.

- The wood structure (studs, top and bottom plates) are damaged at the front window and adjacent areas. These materials show bowing (deformation) and cracks. These must be exposed, reinforced or reattached, and cracked/damaged members replaced with careful attention to supporting and sealing the remaining structure temporarily to prevent further damage.
- The wall penetrations (windows and associated framing – see drawing) are damaged via separation and stress from deformation related to the impact. These also must be replaced to allow for proper function and performance.
- The window units (both sides including missing and separated glazing) must be replaced at the front along with any damaged shutters and trim. Damaged and separated windows must be replaced.

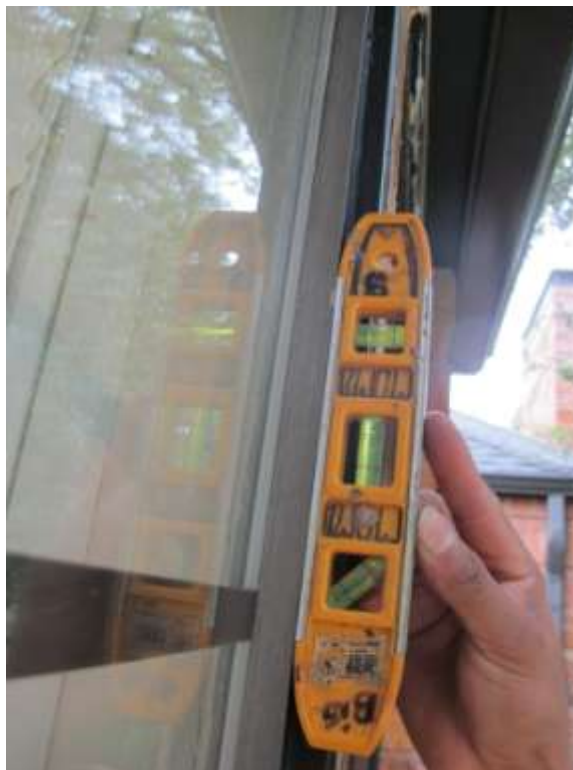
Photo 14: Outward bow or displacement at the upper window frame above impact area.

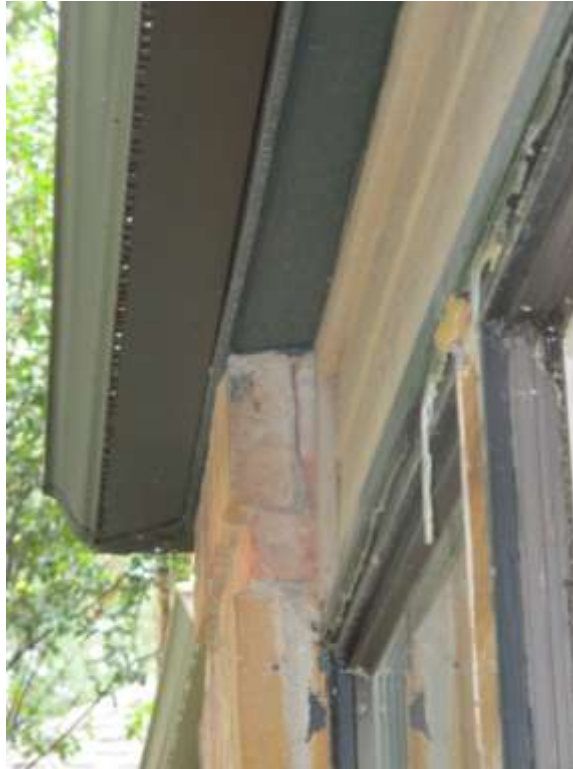
Photo 23: Separation of the gutter and frieze board at the impact area.

- The brick veneer at the impact zone and adjacent areas shows new cracking and separations related to vibration and deflection at the time of impact and subsequent slow deformation to relieve stress. The exterior brick veneer must be replaced in the affected areas including those adjacent to the impact zone. This must be done in coordination with wall structural repairs.
- The separated frieze board at the front impact area is separated and must be repaired.

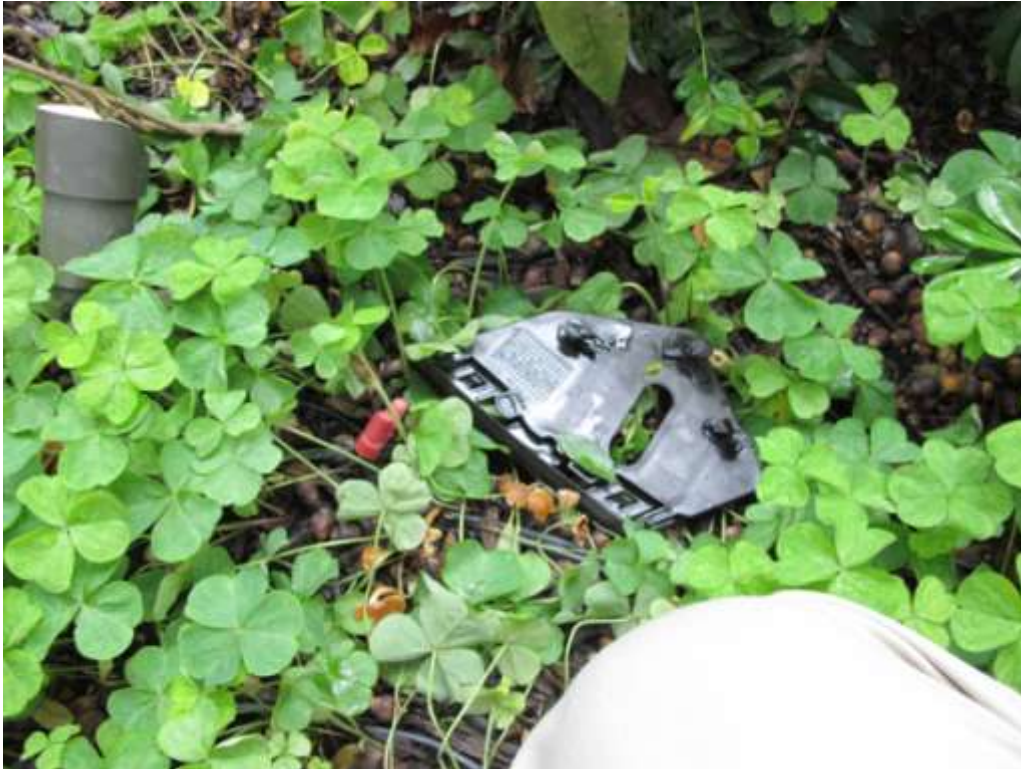
Photo 27: Remaining vehicle body parts in the bed outside impact area.

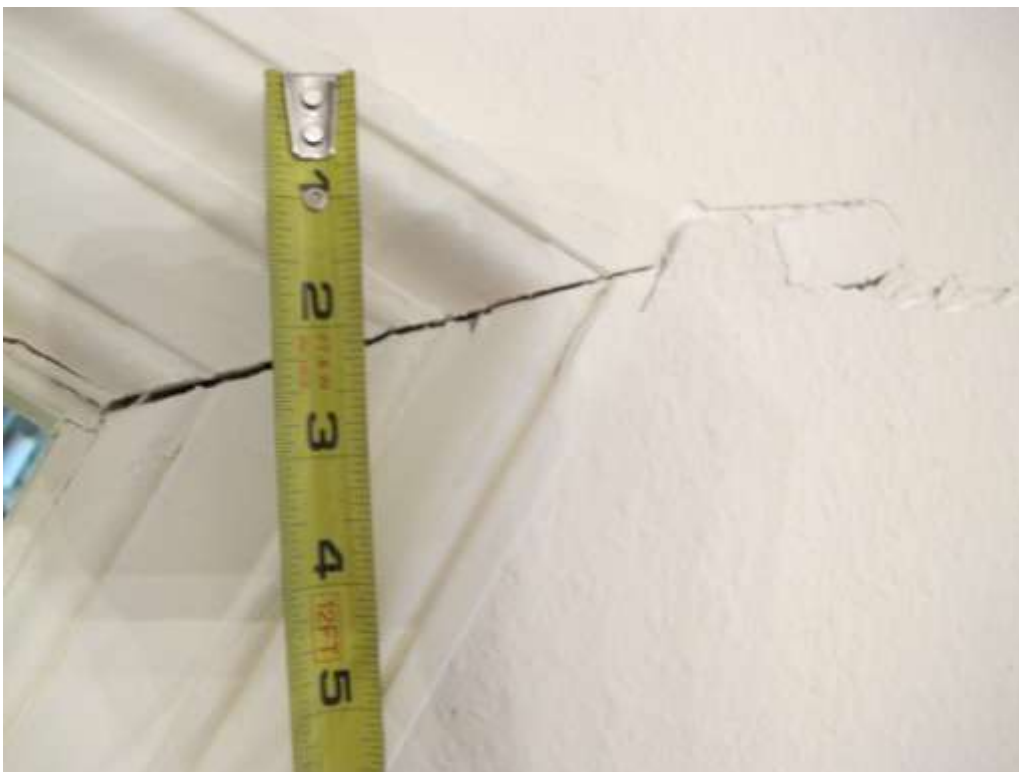
Photo 36: Close up of previous photo.

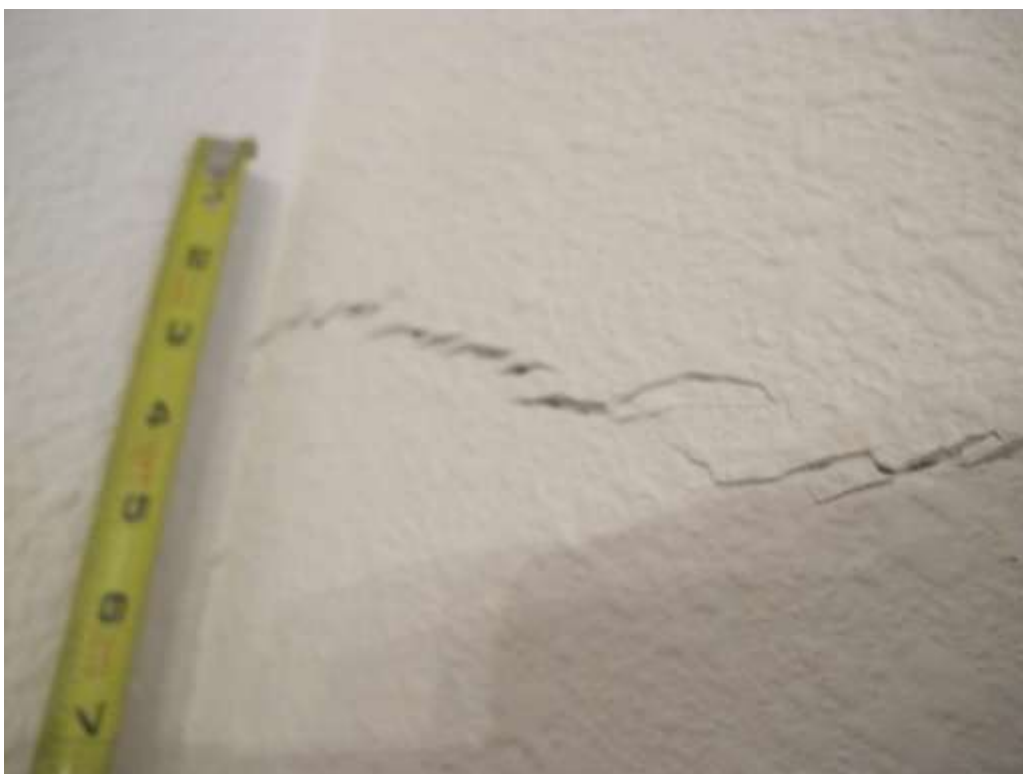
Photo 38: Close up of previous photo.
